Risk assessment through landslide susceptibility map

Chiara Calligaris*, Giorgio Poretti*, Shahina Tariq** and Hawas Khan***

Islamabad, 9-10 th September 2013

The aim of the project is the identification of the **landslide-prone areas inside the borders of the Central Karakorum National Park (CKNP)** in order to have a **first landslide inventory in the area**.

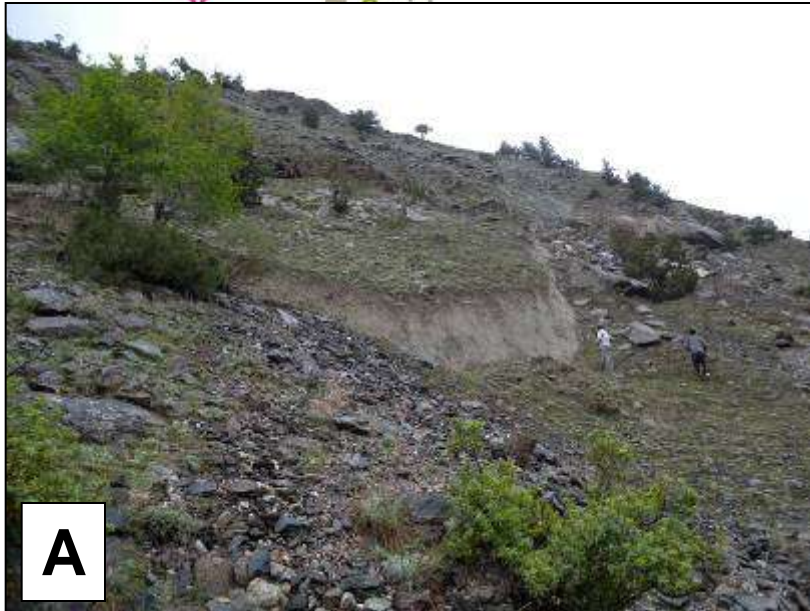
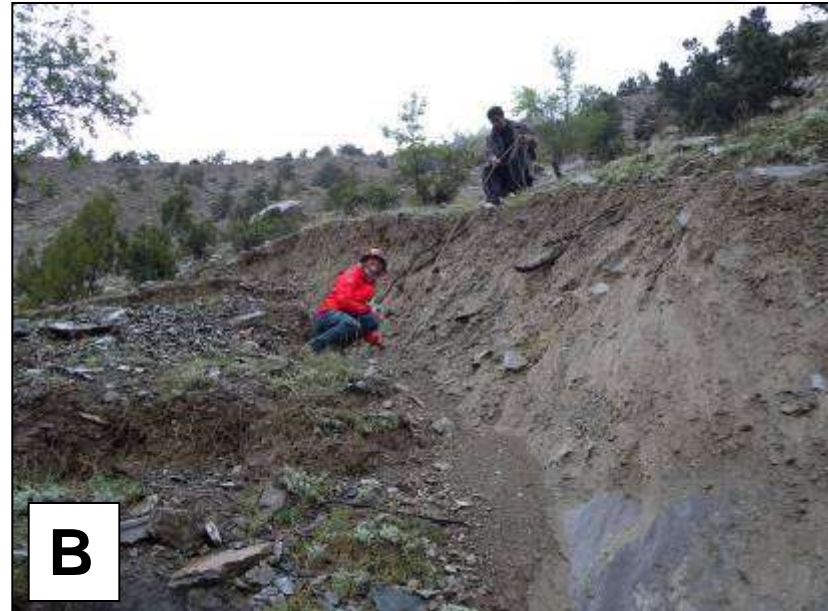
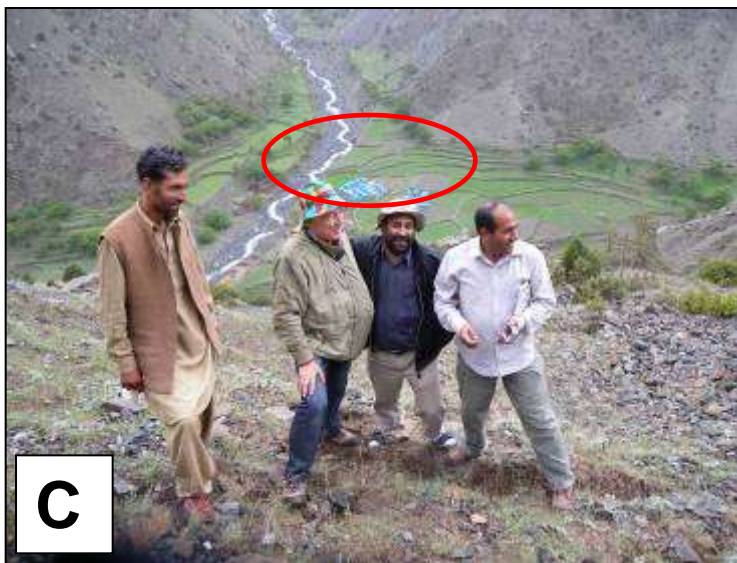
Lateral view of the slope deformation

The **Khaltaro landslide** is a sliding movement of detrital material over a rocky dipping surface. The length of the crown is approximately 200m, the height of the main scarp is about 4 m (**A** and **B**), all around the crown there are tension cracks 1,5m wide. Walking on the main body (**C**), it is possible to identify several longitudinal tension cracks with a gap of 10 to 15cm. This landslide is particular because there is a village with houses and fields at the toe of the slope, on the right side of the river. The phenomenon is moving towards the settlement. Witnesses reported that the movement began in 2009. Now the Pakistani government put up some tents (red circle) in a safer place (**C**), close to the village in order to avoid a possible disaster; **C**: Researchers on the main body of the landslide. On the background the blue tents belonging to the Civil Defence.

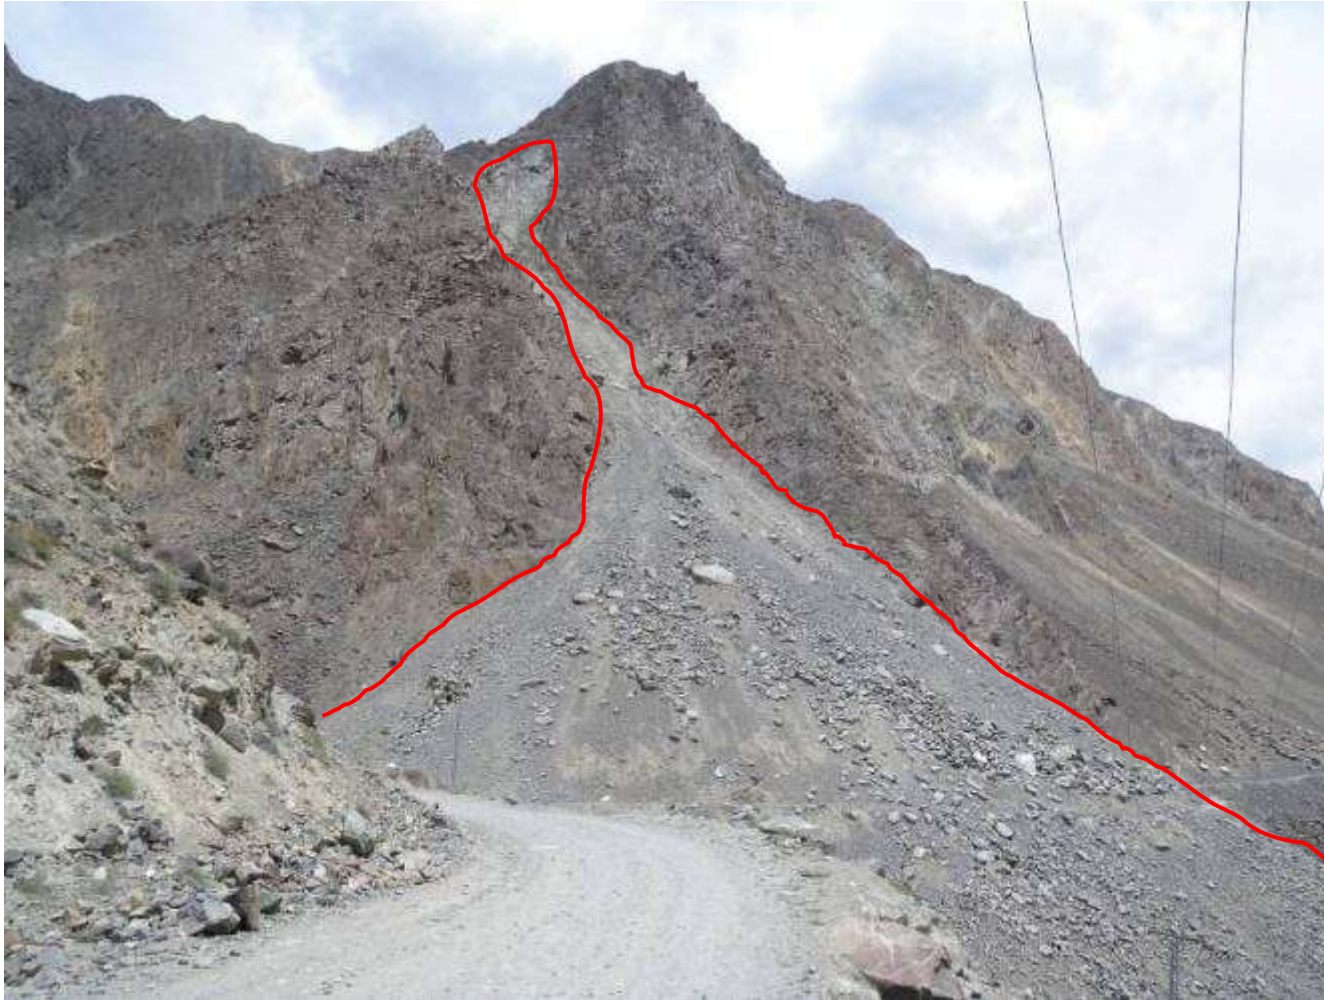
Landslides represent a constant danger along the roads accessing to the CKNP from every direction. On the right an example in the **Bagrot Valley. In red the active fan.**

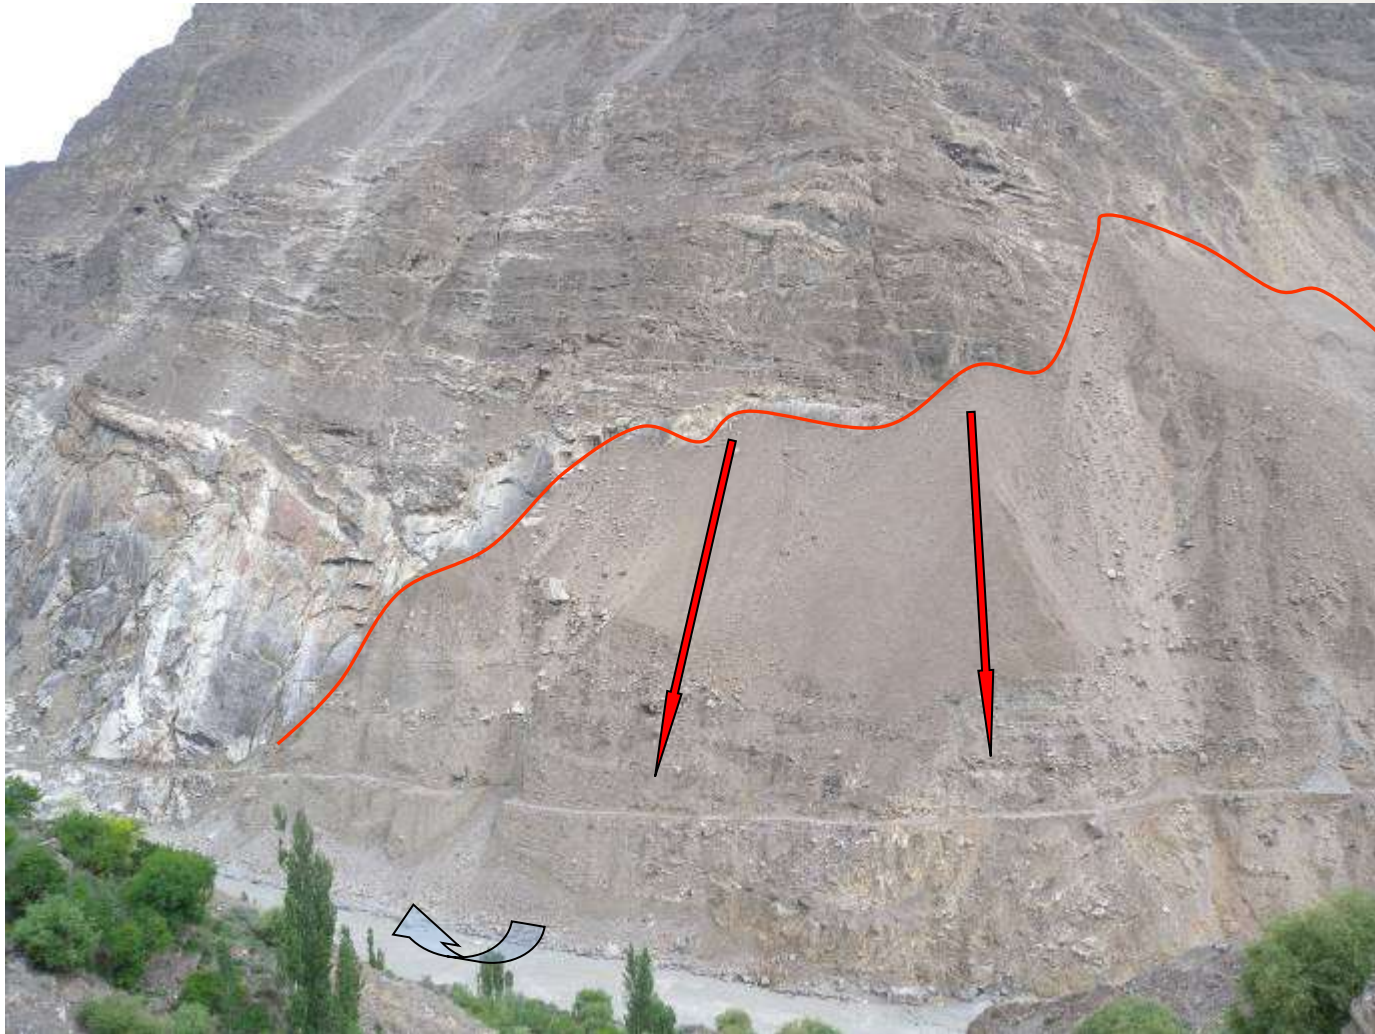
On the way to Hopar glacier: the old road realized in a dangerous place. Fluvial banks erosion is one of the main triggering factors of the landslides in these narrow valleys.

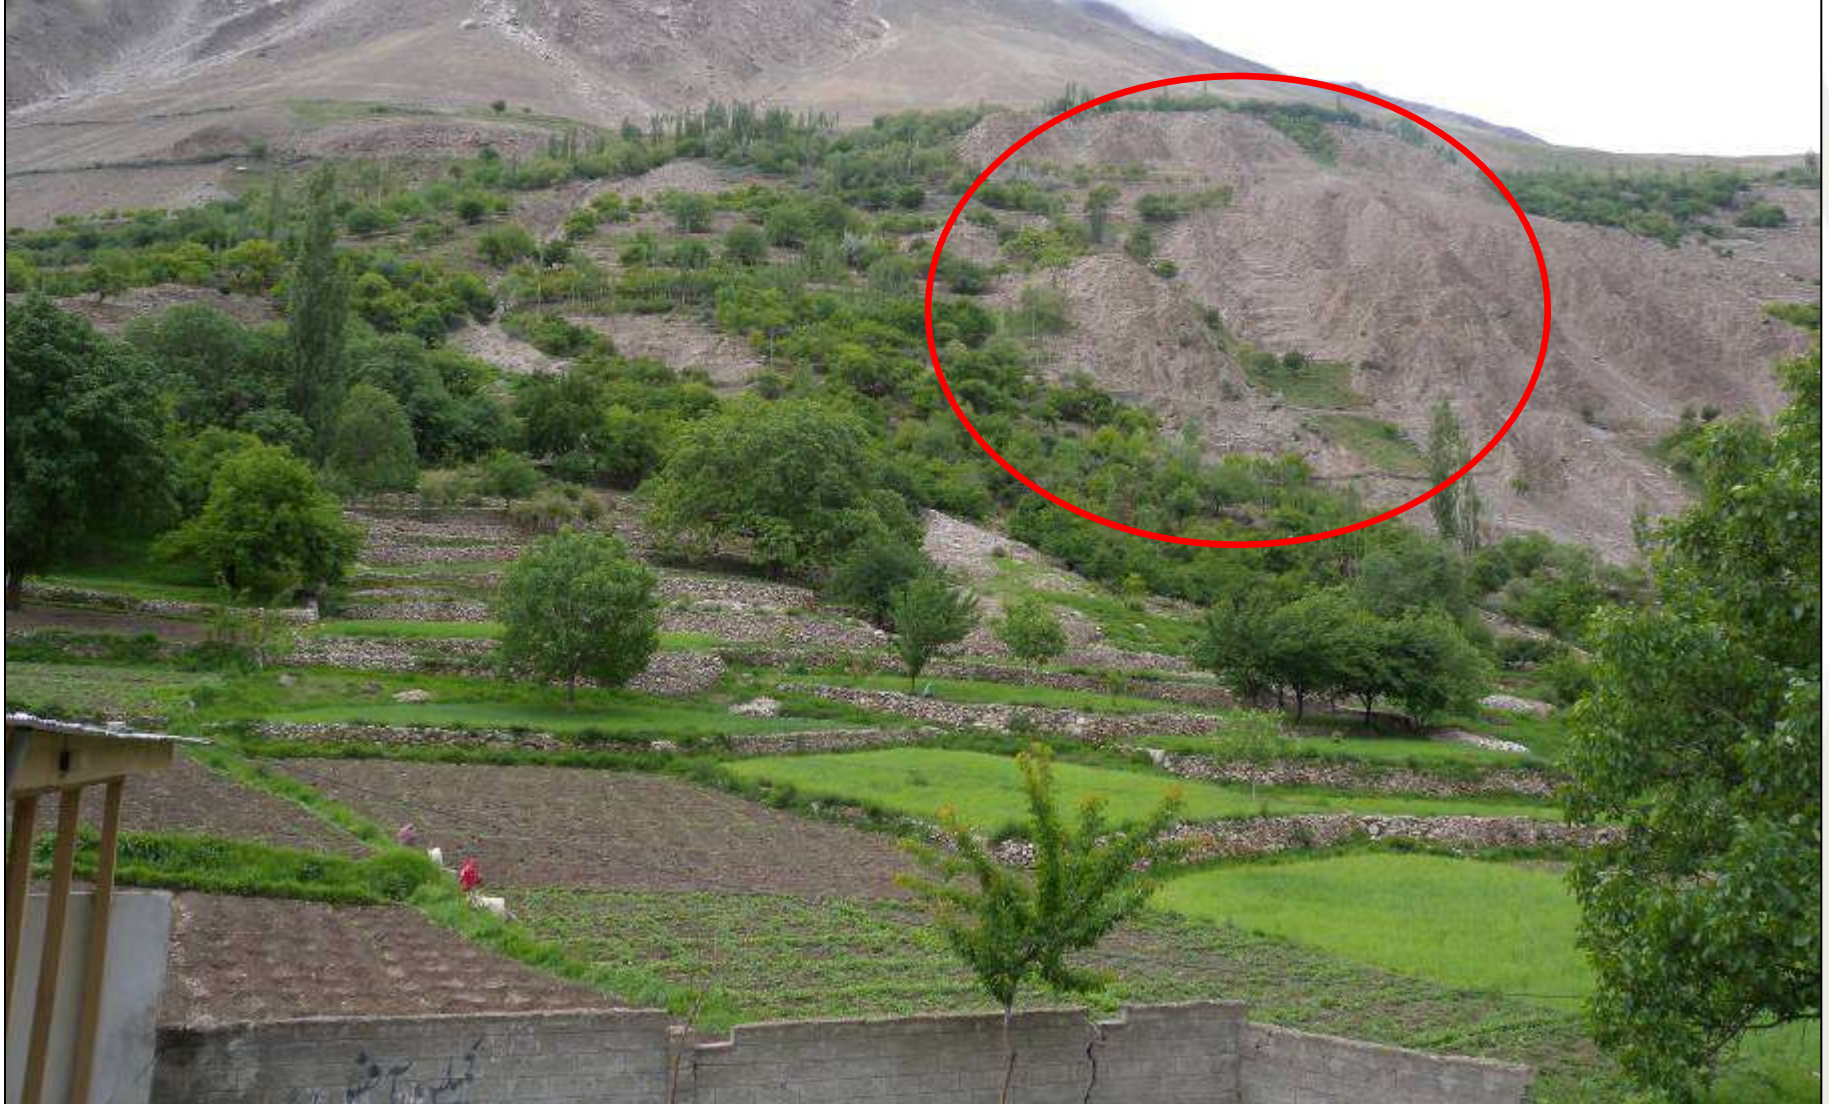
Upper Nagar village (red circle) is protected from the Hunza river by a ridge of about 4400m. This situation allowed the inhabitants to build a nice and quiet village. At the end of the village, on the way to Hopar, a landslide is overhanging the cultivated fields and the houses. This landslide is in moraine material and is due to the steep slopes. To stabilize it, it will be necessary to reshape the entire slope with terraces as they are doing in Italy in the San Remo area. This will allow the cultivation of more fields and to have a better hydrogeological control of the area. Drainage will be recommended.

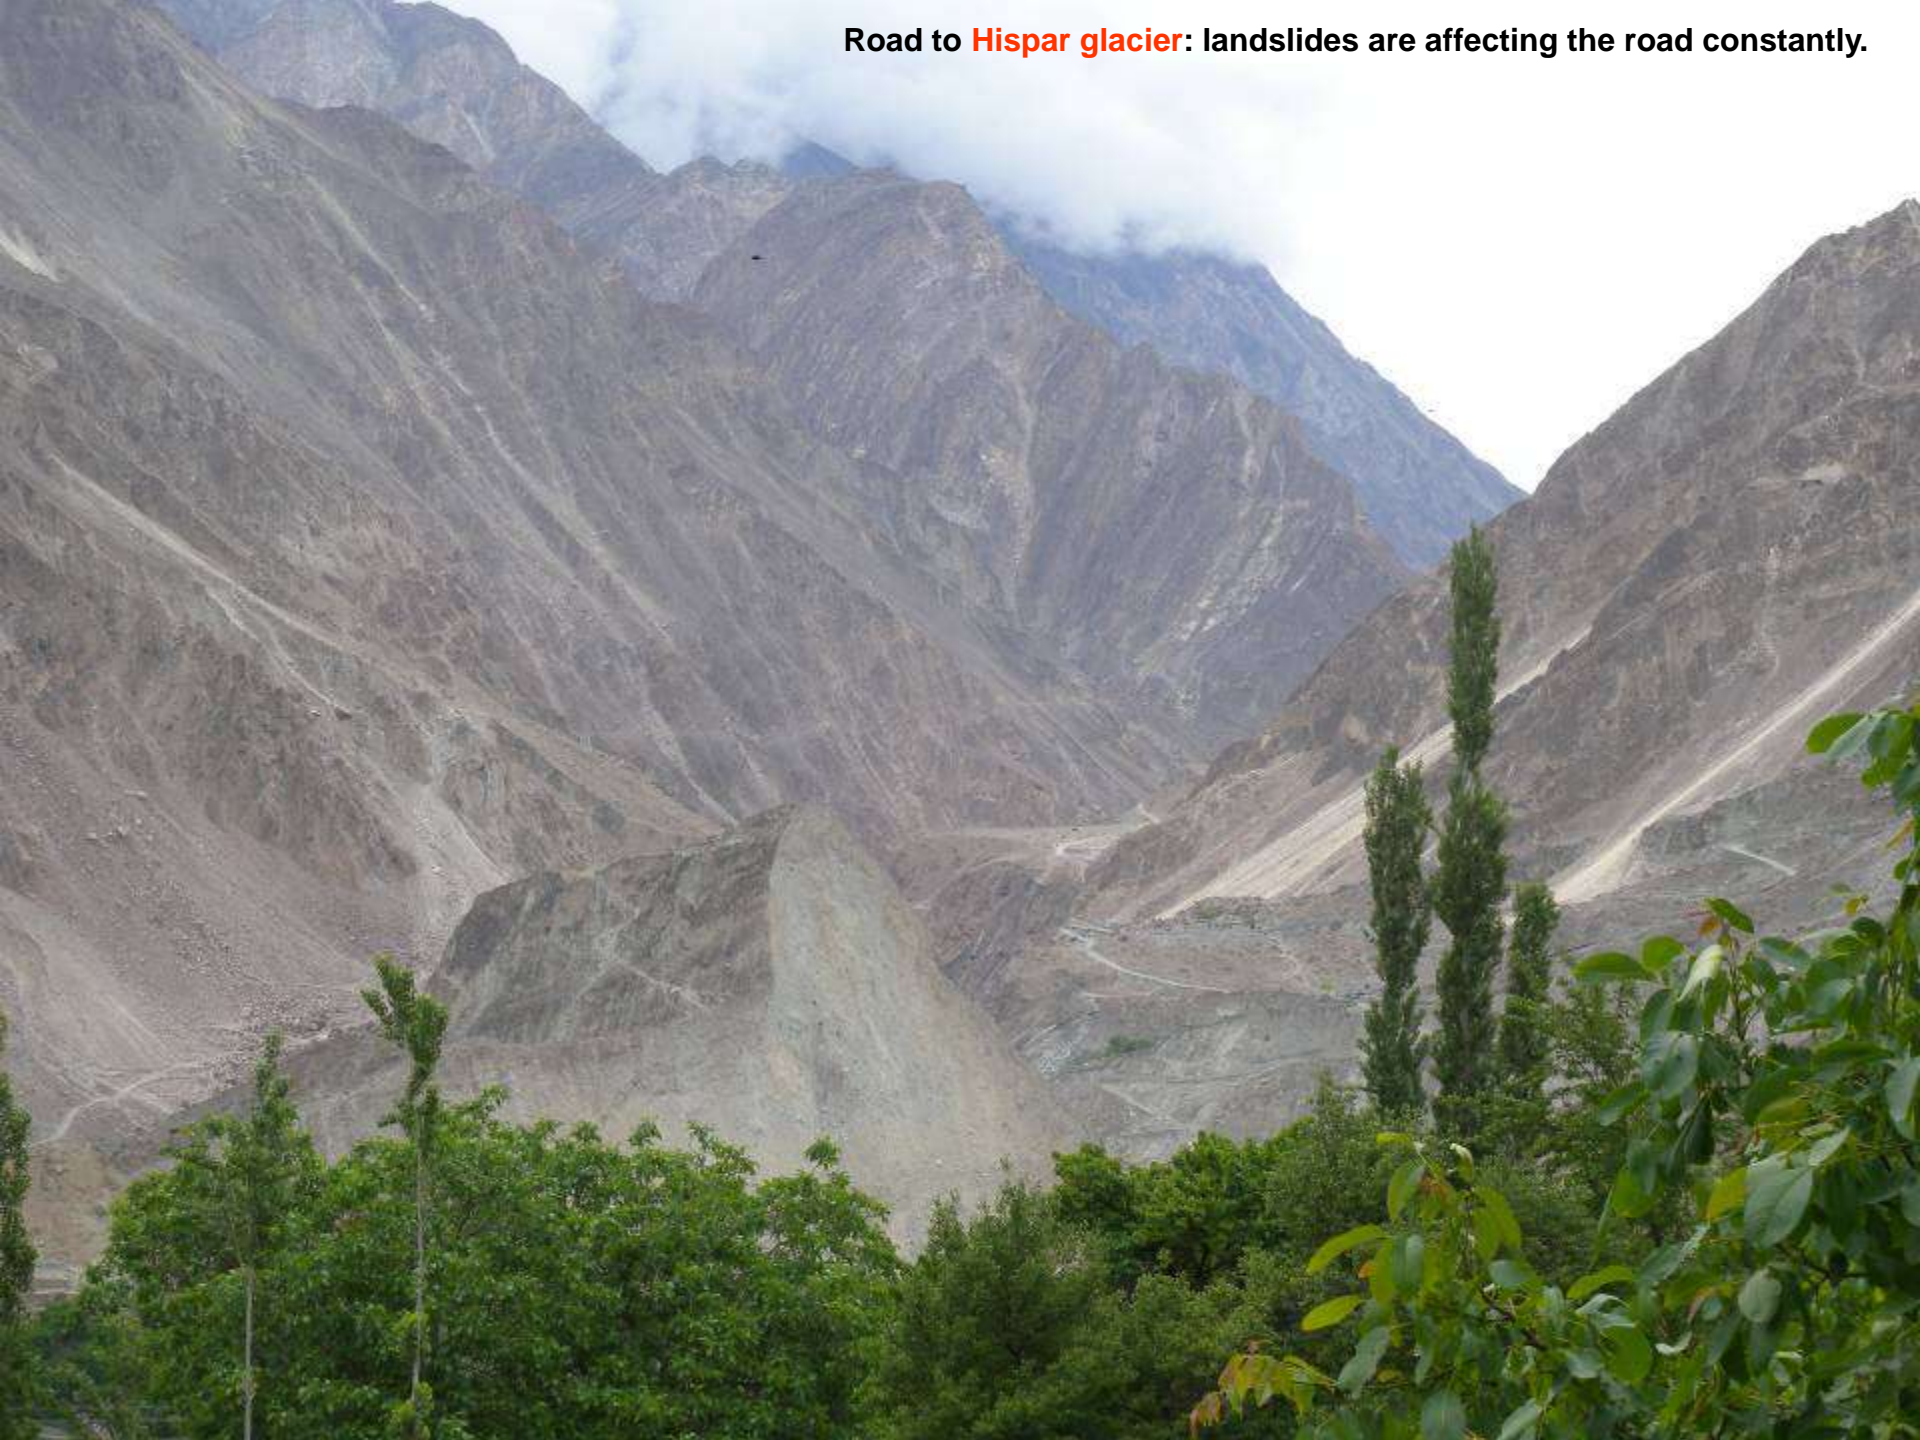
Road to **Hispar glacier**: landslides are affecting the road constantly.

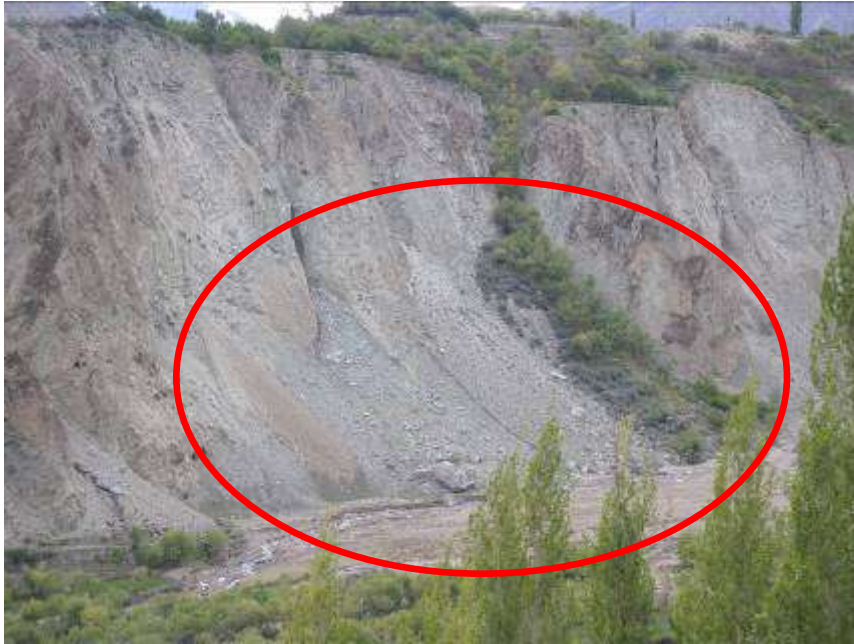
Terraces banks are one of the most instable slopes due to their steepness and the nature of the involved loose or poorly cemented material.

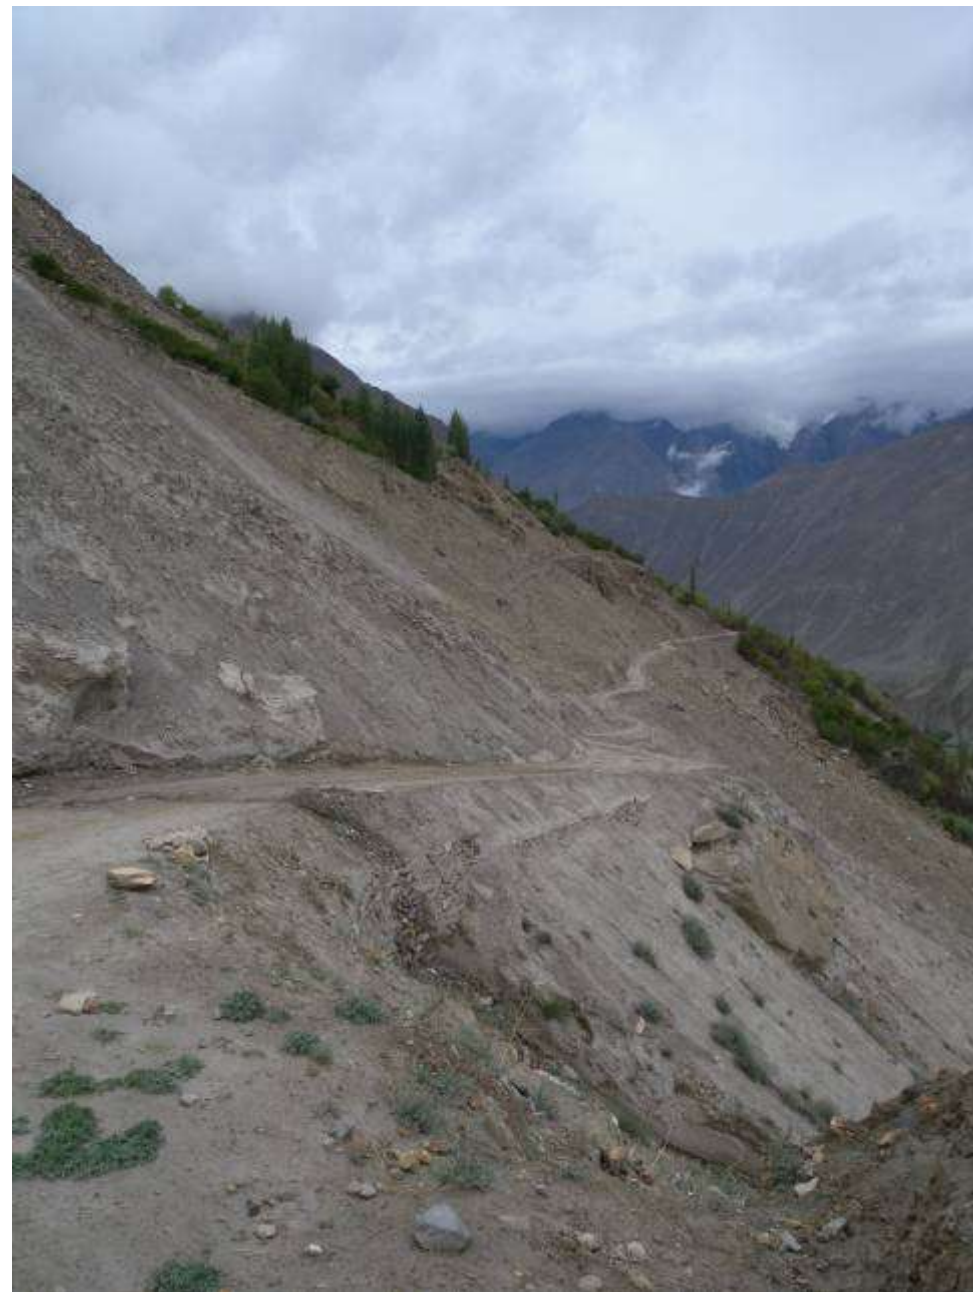
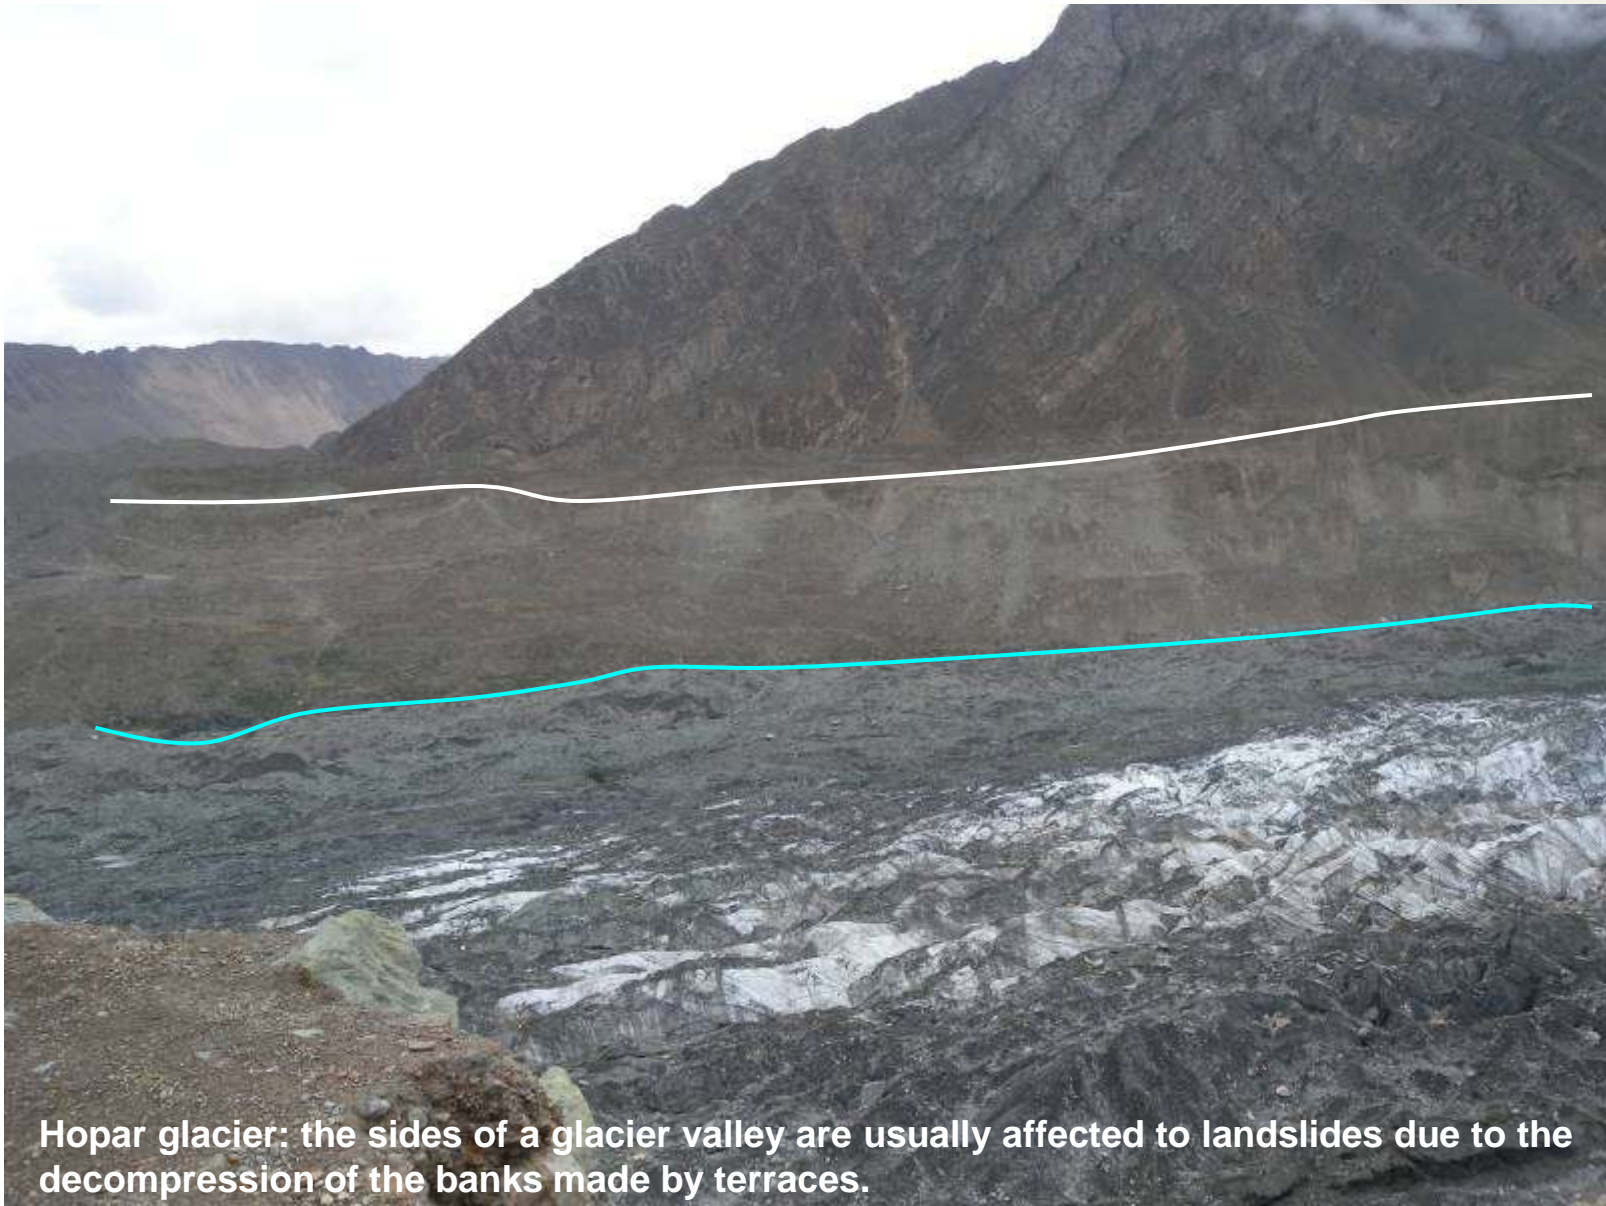
Scarps are always affected by landslides all over the year but especially during the monsoon seasons

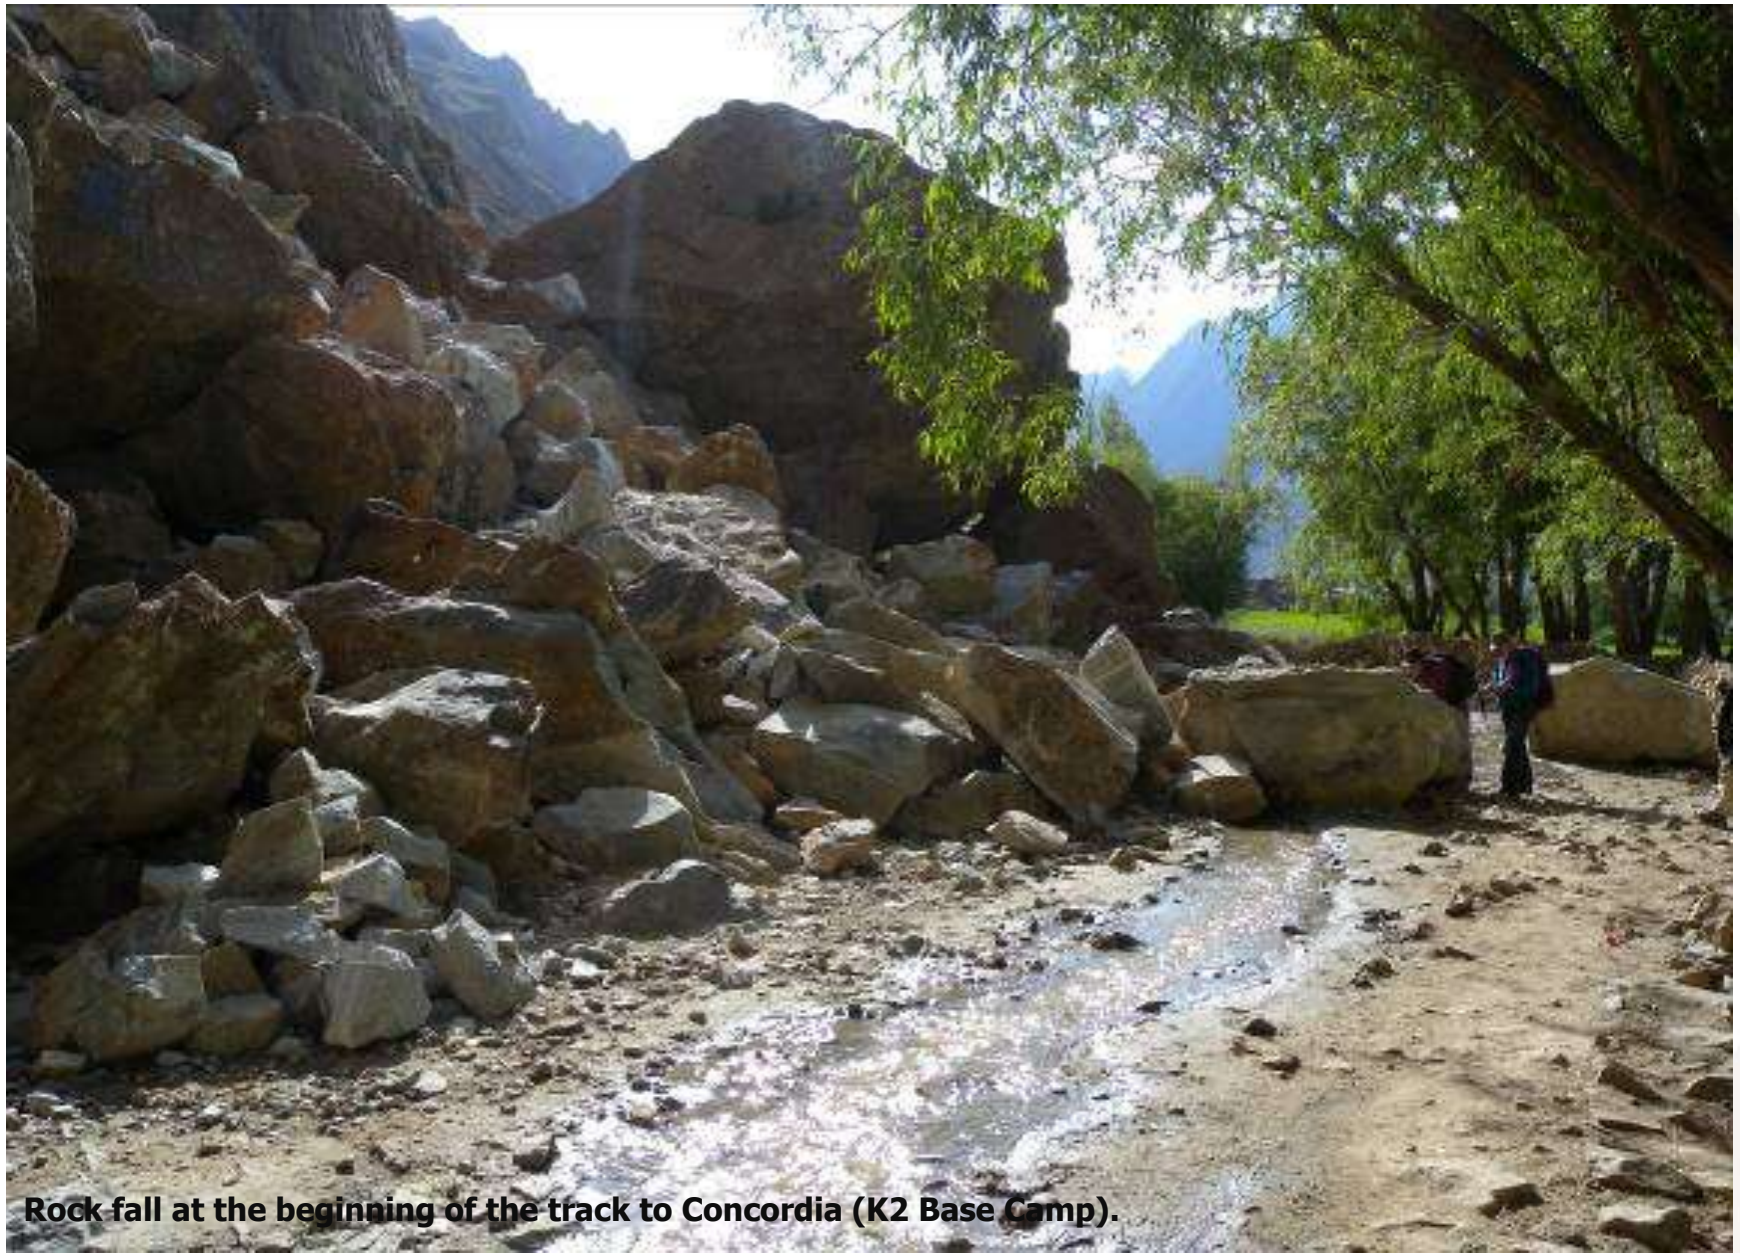
Biafo glacier area: an opening fracture
